PROJECT: GROUND INVESTIGATION
LOCATION: EXCEL PHASE 3, LONDON DOCKLANDS
VALUE: £100K

BACKGROUND

The site investigation took place in the eastern car park of ExCel Exhibition Centre in order to provide information on ground conditions to inform foundation design, contamination assessments, and any remedial measurements required for the construction of a two-storey, 40,000m² extension.

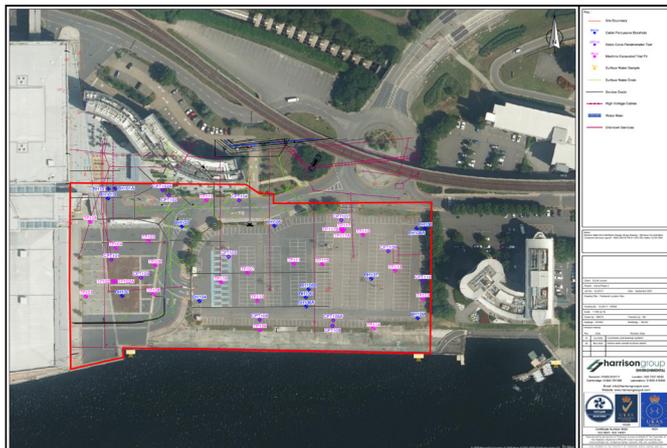
Site plan showing intrusive investigation positions

- 14no. cable percussive boreholes up to 30m in depth
- 11no. combined magnetometer-cone penetrometer tests, including 7no. dissipation tests
- 22no. machine excavated trial pits
- 2no. falling head permeability tests

- Regular ground gas and water monitoring, with collection of groundwater and gas canister samples
- Continuous gas and groundwater monitoring at two locations.

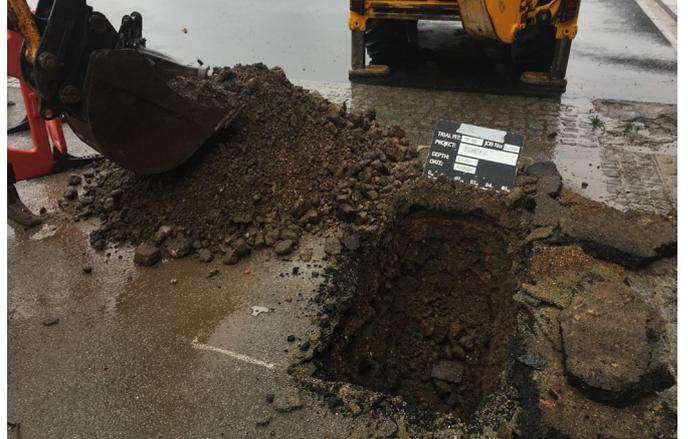
Typical machine-excavated trial pit

The site also presented numerous challenges that put further pressure on the deadline, including blowing sand, gross hydrocarbon contamination, and breaking through historical obstructions, which in some places involved more than a metre of concrete and caused several locations to be terminated early and relocated. This was also the case for a further three borehole positions, working on the advice of a specialist UXO engineer, due to high UXO readings.
