**PROJECT: GROUND INVESTIGATION**  
**LOCATION: EXCEL PHASE 3, LONDON DOCKLANDS**  
**VALUE: £100K**

## BACKGROUND

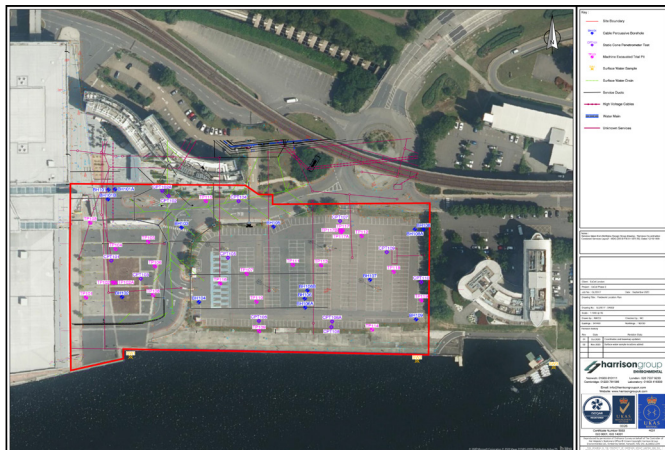
Site plan showing intrusive investigation positions

- 14no. cable percussive boreholes up to 30m in depth
- 11no. combined magnetometer-cone penetrometer tests, including 7no. dissipation tests
- 22no. machine excavated trial pits
- 2no. falling head permeability tests

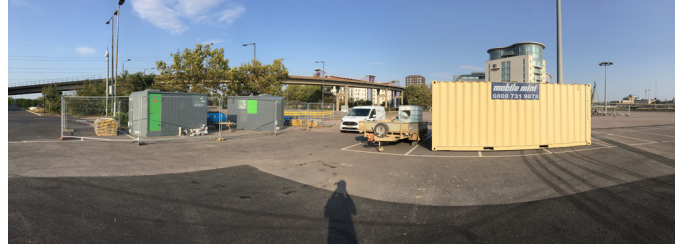
Welfare facilities & Covid-19 compliance. Health and safety methods adopted to work successfully with social-distancing & to minimise cross-contamination risk

The site was set up and ran to facilitate Covid-compliant social distancing, with measures such as additional welfare facilities put in place.

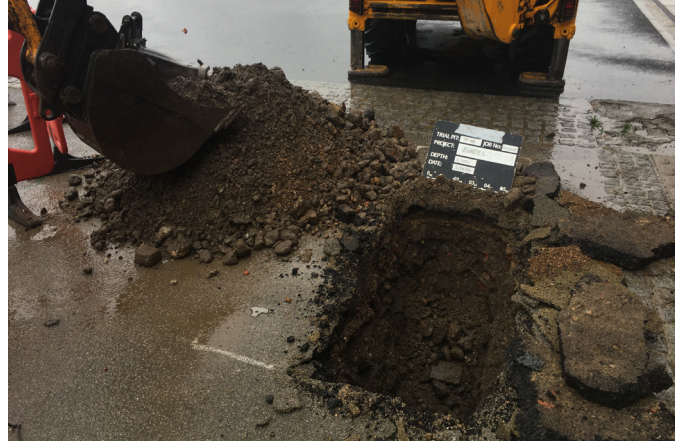
Typical machine-excavated trial pit

The site also presented numerous challenges that put further pressure on the deadline, including blowing sand, gross hydrocarbon contamination, and breaking through historical obstructions, which in some places involved more than a metre of concrete and caused several locations to be terminated early and relocated. This was also the case for a further three borehole positions, working on the advice of a specialist UXO engineer, due to high UXO readings.
